Black out blind

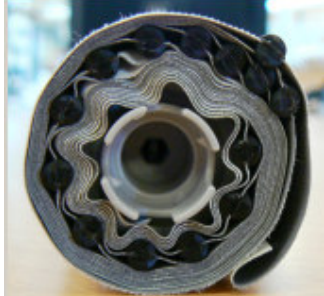
S:\VELUX\A-DRA\ Prodsupp\GIS\DSL_RS
All D- - Cloth droops.	As the blind must be subject to tolerances both of the window and the product itself, the cloth may appear somewhat large. Both the window and the cloth are "working" (they enlarge and decrease because of changes in temperature).	Cloth will always droop.
	The cloth material is made of flexible textile.	Design requires that the cloth can be rolled round the roller tube.
	Gravity pulls the cloth in an inappropriate way in relation to e.g. vertical blinds, which are positioned vertically, where the gravity also pulls in this direction.	Gravity is a law of nature, which cannot be abolished.
All D-- Small marks/folds on the cloth (product has been fitted for less than two days).	The cloth has been rolled up since the blind left production.

Leaving the product lowered for 1-2 days will by and large remove folds.

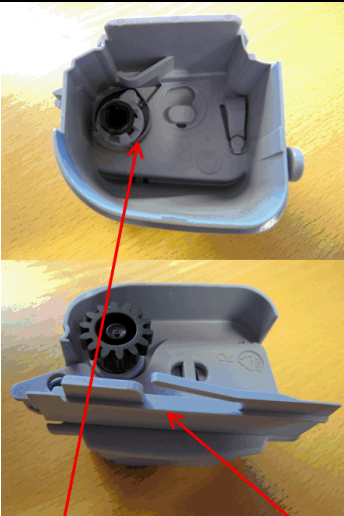
The "release spring" can have problems holding the "side guide" in 90°. Therefore the blind get's in "manuel release mode", and the blind keeps on running/clicking.	1) Take of the spring and bend it so it gets stronger. 2) Replace the whole unit in both sizes.

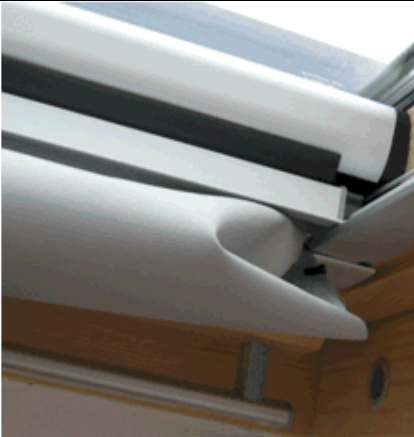
Control the control system if the motor do not get power.
DMH/DMC/DMD The last 10-15 cm cloth will not go into the top unit
