172 KPH

Recognised test facility testing weakest points

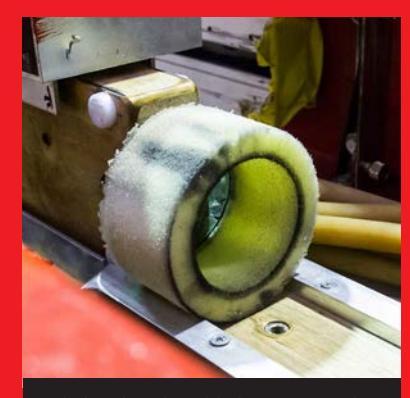
The launcher released 'hailstones' at speeds of up to 172 kph

We submitted three VELUX skylights - an openable, a fixed and a flat roof skylight – to Australia's first hail test of residential glass skylights. The test was conducted by the nationally recognised IBA test centre in Melbourne in accordance with ASTM E822-2009. The test samples were impacted at their weakest points – near the corners. The glass near the corners doesn't give so it cops the full force of the impact...

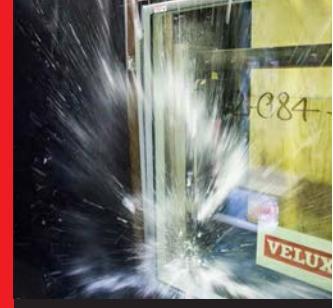
The skylights were hit at their weakest points - the corners

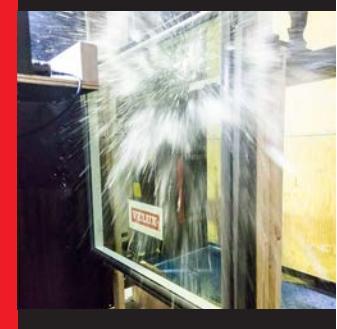
Each skylight was hit four times with 50 mm hailstones at 135 kph and four times with 72 mm hailstones at 150 kph+

to 135 kph. All three VELUX skylights passed without a scratch. 72 mm hailstones travelling at 150 kph+ Finally the diameter of the hailstones was increased to 72 mm – the size of a cricket ball. Weighing 180 g the hailstones were heavier than a cricket ball and they travelled faster, too. All three VELUX skylights were hit once near every corner at speeds ranging from 151 kph to 172 kph – faster than any bowler has ever delivered a cricket ball*. Still the VELUX skylights remained unscratched...

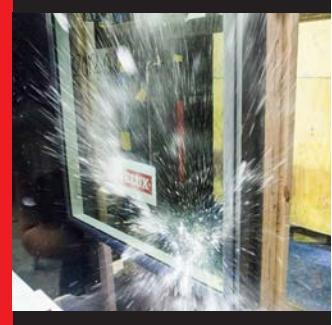
Testing with smaller and slower hailstones was only conducted on one skylight due to lack of impact

The first four man-made hailstones measured 25 mm in diameter and hit the VELUX skylight at a speed of 108 kph. No damage. Realising that more impact was required, the test team increased the size of the hailstones to 35 mm and the speed to 120 kph. Still no damage. Upping the ante, the test team now increased the size of the hailstones to 50 mm and the speed

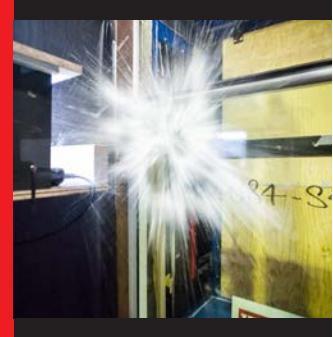
At the end of the test there was no damage at all on any of the three VELUX skylights

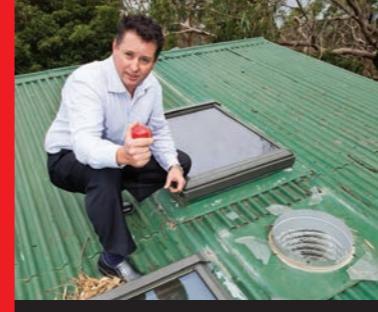
VELUX inspects a roof hit by hailstones the size of cricket balls in the Melbourne storm 2010. All VELUX skylights remained intact.

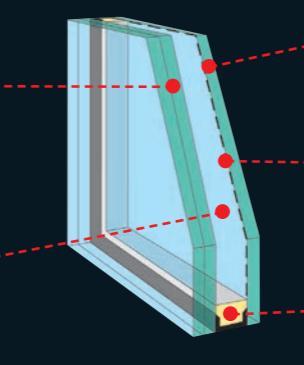
High Performance double glazing (2004)

Laminated inner panes for added . safety.

Argon filled cavity together with Low-E³ coating increases thermal performance by reducing 80% of heat flow through the pane.

Outer pane of toughened safety glass.

Improved Low-E³ coating maximises light transmittance and reduces solar heat gain.

Warm edge technology increases energy efficiency.

But how can they resist hailstones the size and weight of cricket balls without breaking? It's due to the way they are built. The outer pane – which proved too strong for the hailstones in the test – is made of toughened safety glass. Behind it are laminated inner panes for added safety. Have a look below to see how a VELUX skylight is built...
